Principle Home Inspection

Property Inspection Report

Property address: **58820 211th st**

Inspection date: **Tuesday, December 08, 2015**

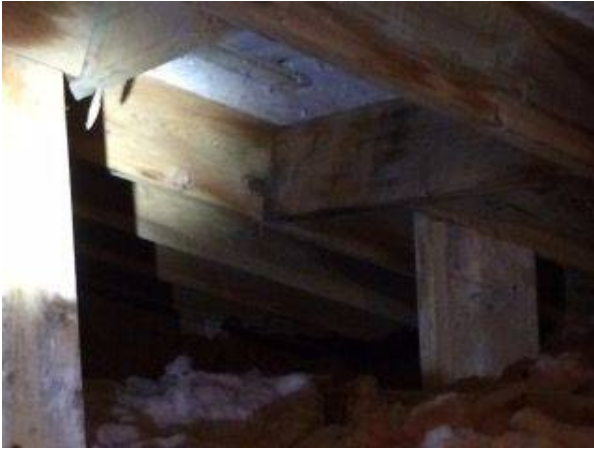
Photo 4-1

One or more rafters in the roof structure were damaged or split. This may significantly weaken the roof structure. Recommend that a qualified contractor repair as necessary.

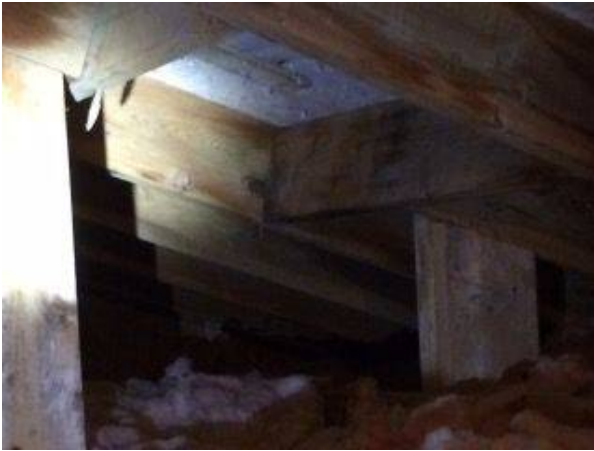
Photo 4-1

- One or more rafters in the roof structure were damaged or split. This may significantly weaken the roof structure. Recommend that a qualified contractor repair as necessary.
